**TEARDOWN REPORT  
OF TWO MODEL TPE331-10T-515K TURBOPROP ENGINES  
SERIAL NUMBER P-79297C AND P-79001C**

**October 8, 2014**

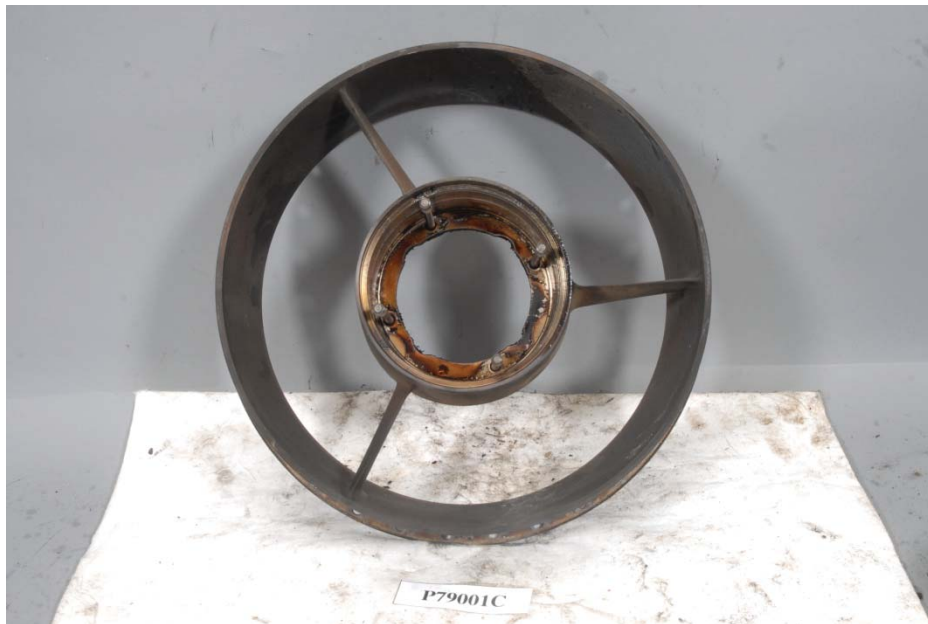
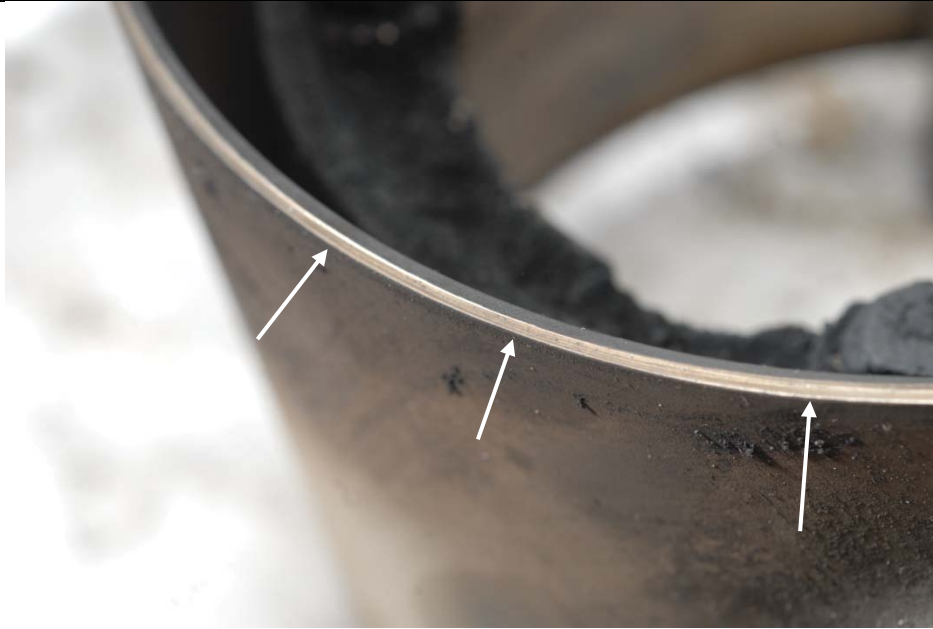
**Figure 373.** P-79001C, Turbine Bearing Support Housing, FLA

- The turbine bearing support housing was intact.
  - The turbine bearing support housing displayed rotational scoring to the forward face on the inner housing of the rear bearing support with corresponding rotational scoring on the aft blade platforms of the third-stage turbine wheel. (Figure 375)

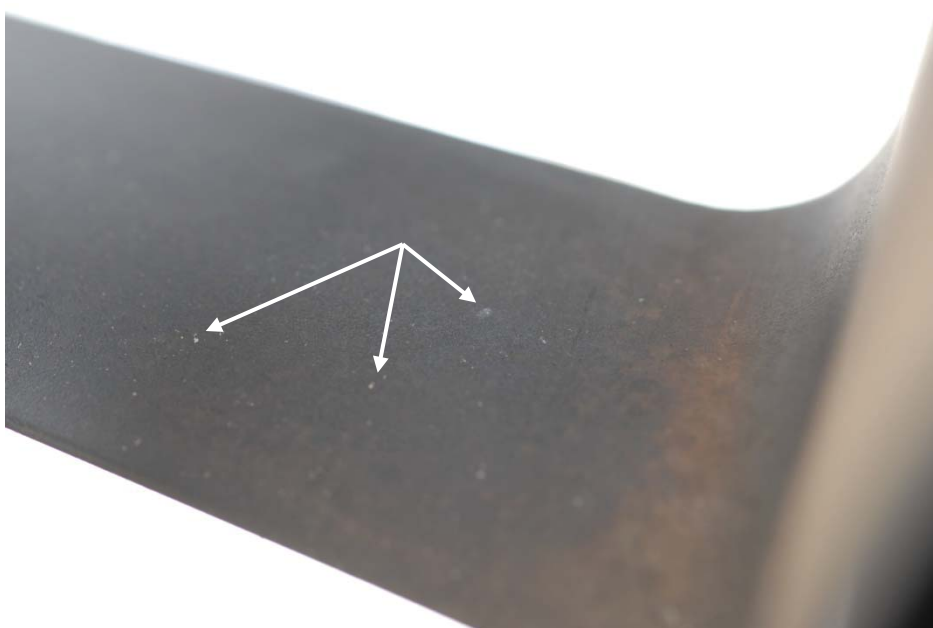
**Figure 375.** P-79001C, Turbine Bearing Support Housing, Rotational Scoring

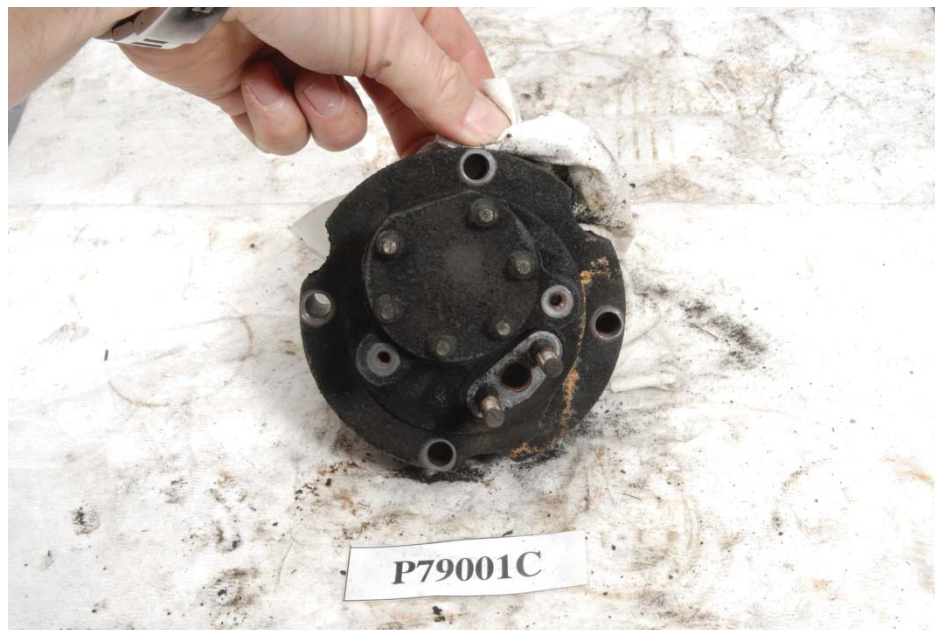
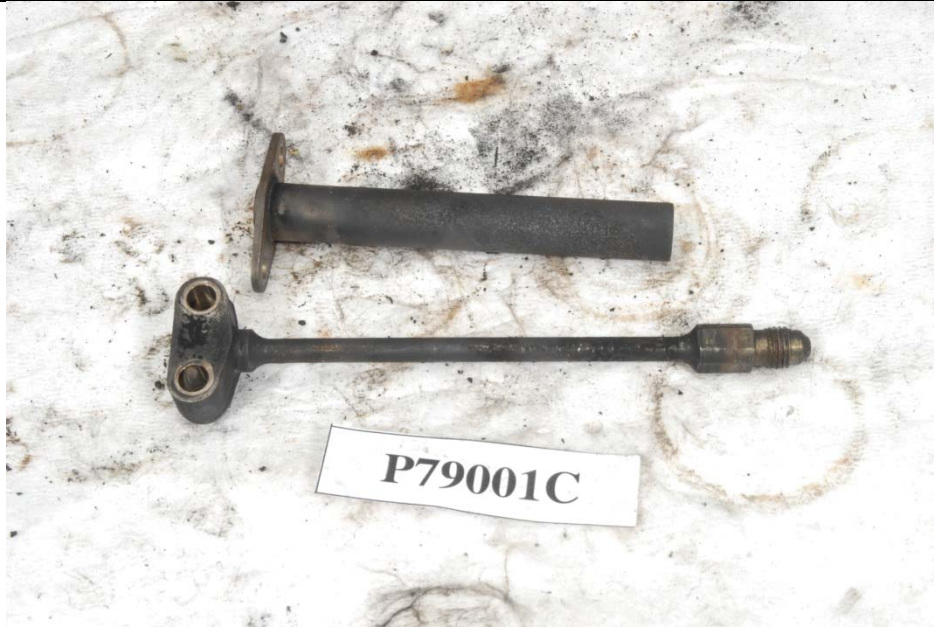
**Figure 377.** P-79001C, Turbine Oil-Scavenge Pump and Drive Shaft, FLA

- (l) Turbine Oil-Scavenge Pump and Drive Shaft: (Figure 377 and Figure 378)
  - The turbine oil-scavenge pump element drive gear appeared to be undamaged.

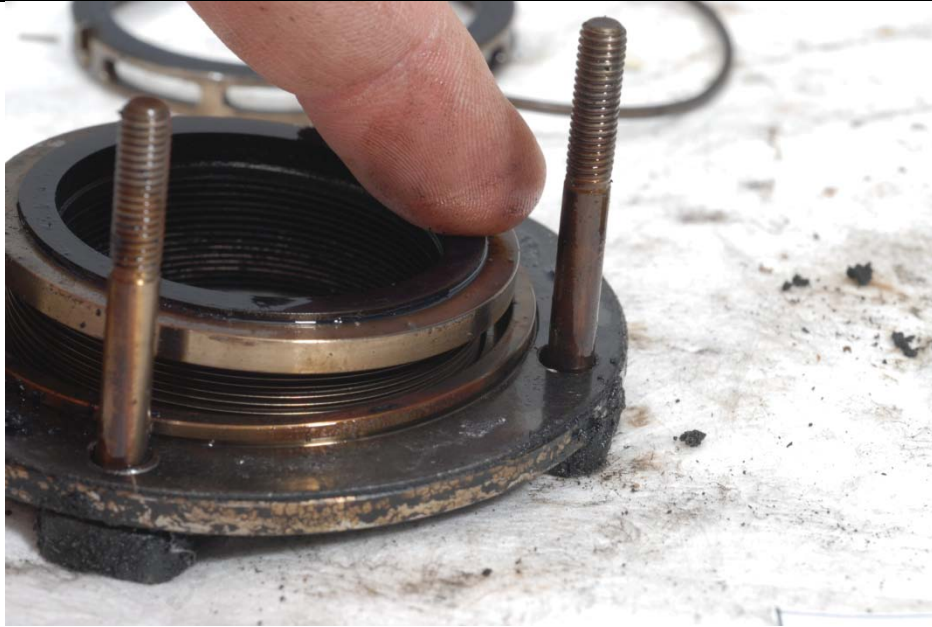
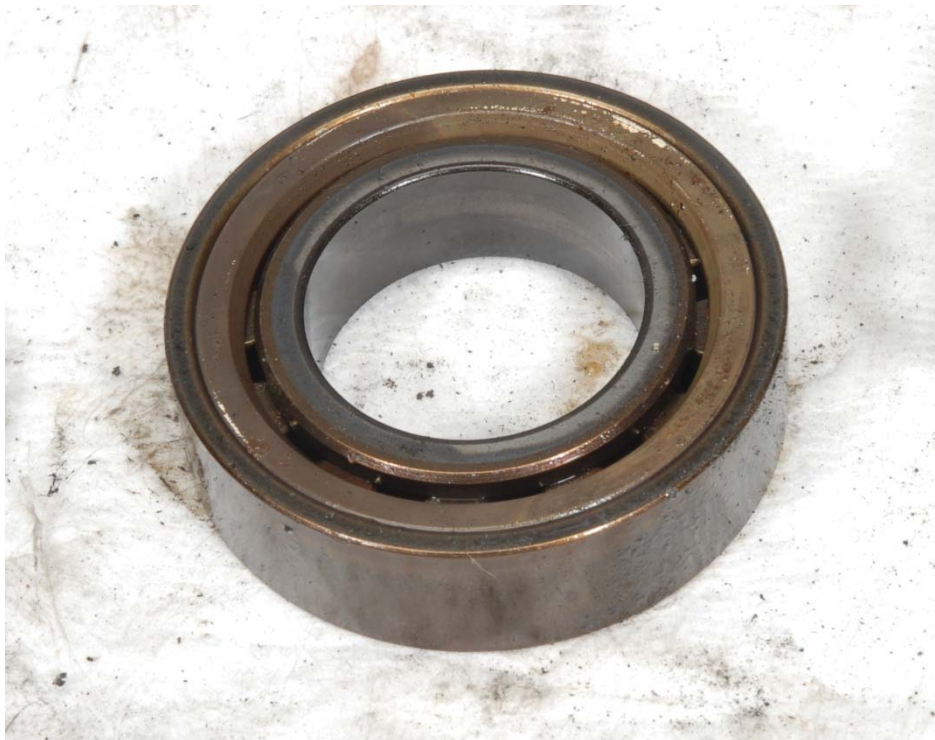
**Figure 380.** P-79001C, Turbine Air/Oil Carbon Seal

- (n) Turbine Air/Oil Carbon Seal: (Figure 380 and Figure 381)
  - The turbine air/oil carbon element appeared to be undamaged.
  - The turbine air/oil carbon element supporting spring appeared to be undamaged and retained spring action/force.

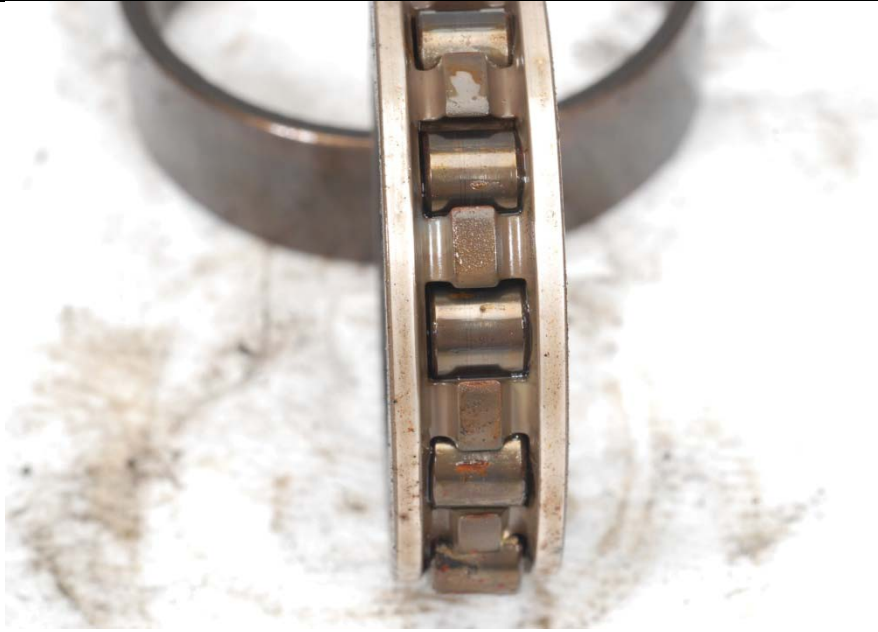
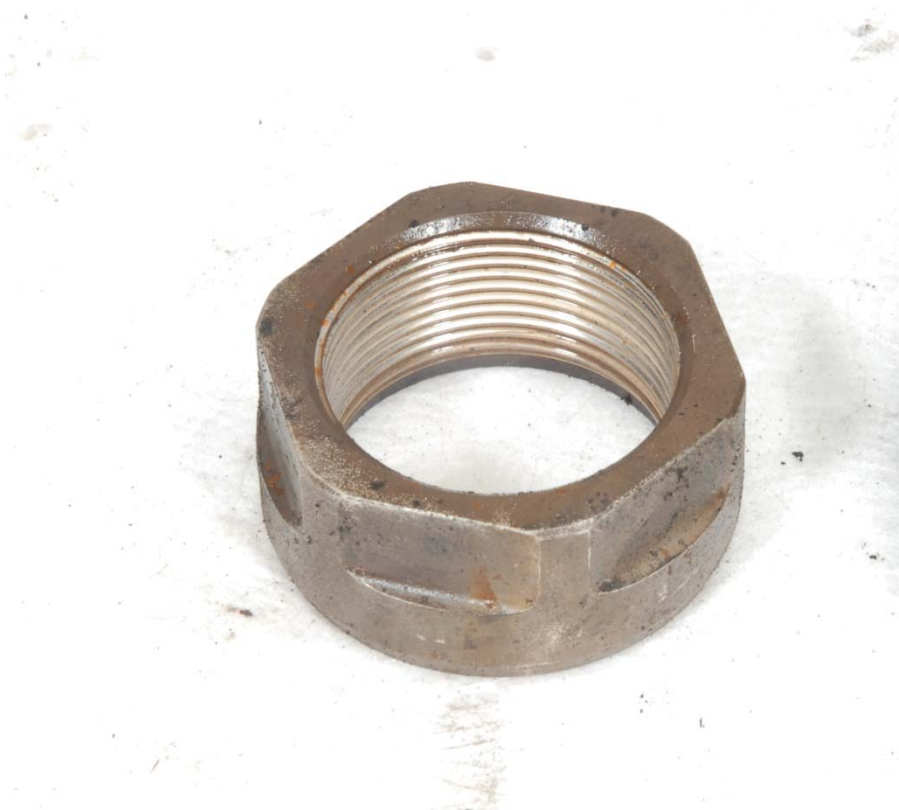
**Figure 382.** P-79001C, Turbine Bearing

- (o) Turbine Bearing: (Figure 382 and Figure 383)
  - The turbine bearing was intact
  - The turbine bearing appeared to be undamaged.
  - There was residual oil present.

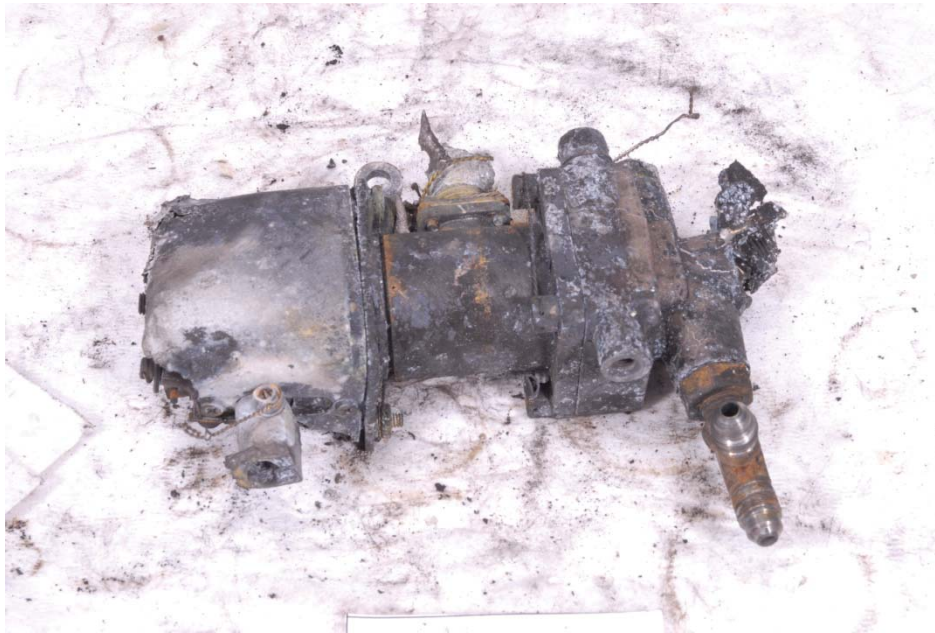
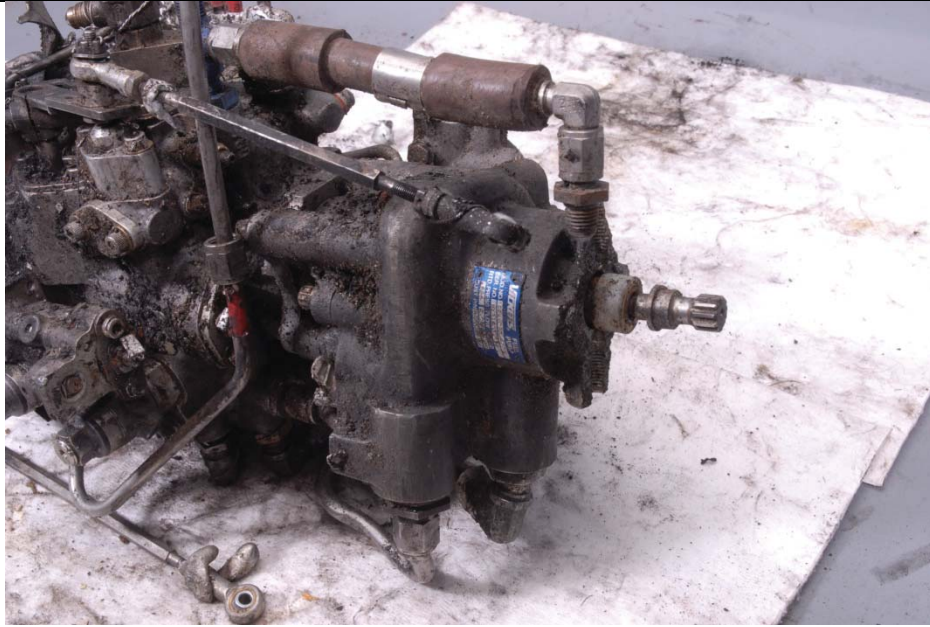
**Figure 385.** P-79001C, Manual Fuel Shutoff Valve

- (a) Manual Fuel Shutoff Valve: (Figure 385 and Figure 386)
  - Part Number: 394230-9-1
  - Serial Number: indiscernible, name plate was consumed in the post crash fire.

- The manual fuel shutoff valve was heavily damaged by fire, including much of the solenoid, valve body, electrical connector, and actuator arm.
- (b) Fuel Pump Assembly: (Figure 387 and Figure 388)

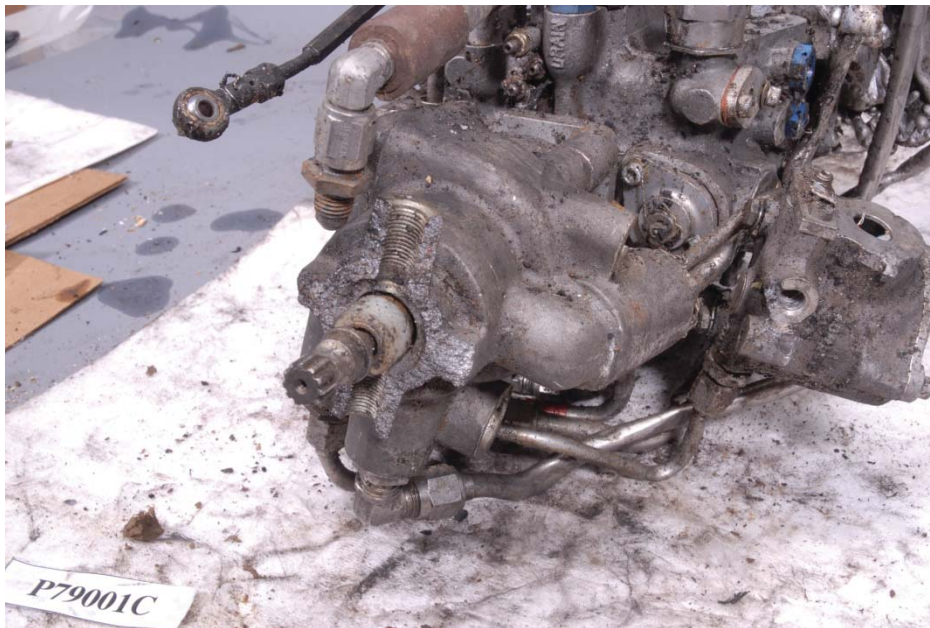
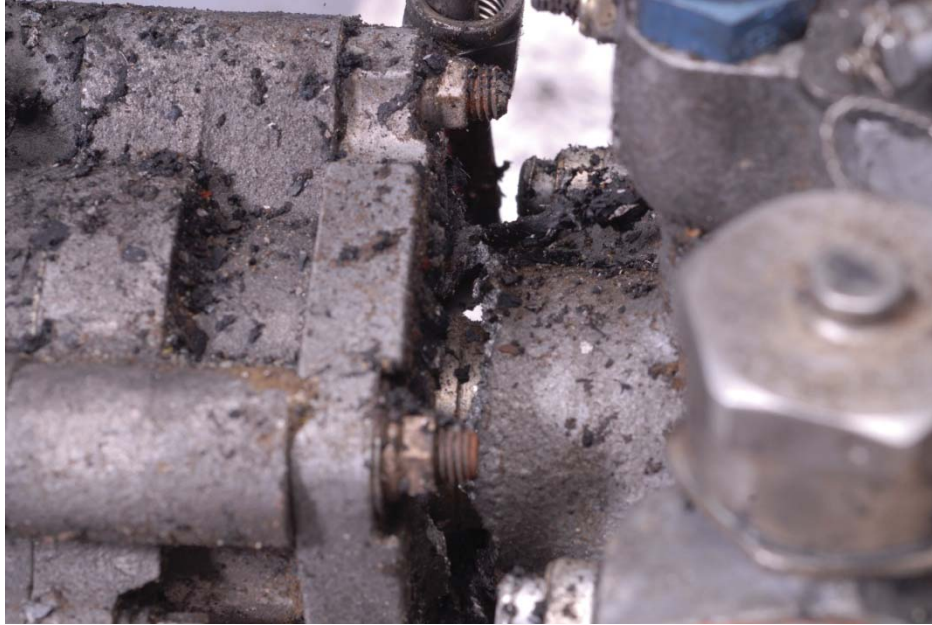
**Figure 387.** P-79001C, Fuel Pump Assembly

- The fuel pump was damaged due to exposure to heat.
- (c) Fuel Control: (Figure 390 and Figure 391)
  - Part Number: 893528-32
  - Serial Number: 335290

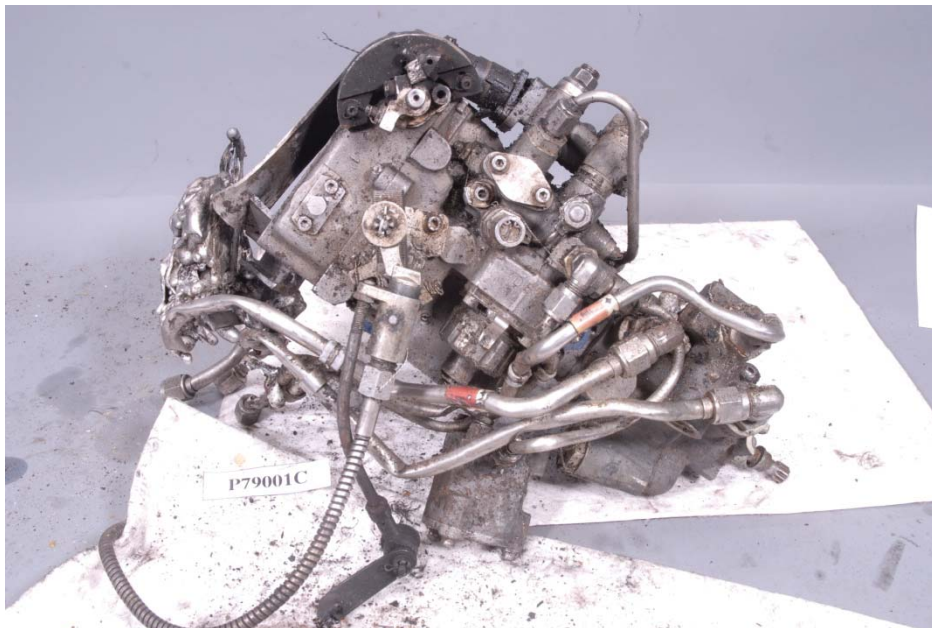
**Figure 389.** P-79001C, Fuel Pump Assembly and Fuel Control Interface

- Part Number: PF4-057-6D
  - Serial Number: MX316031
  - The fuel pumps were not separated from the fuel control during disassembly, but were fractured aft of the mounting flange in the fuel control. (Figure 389)

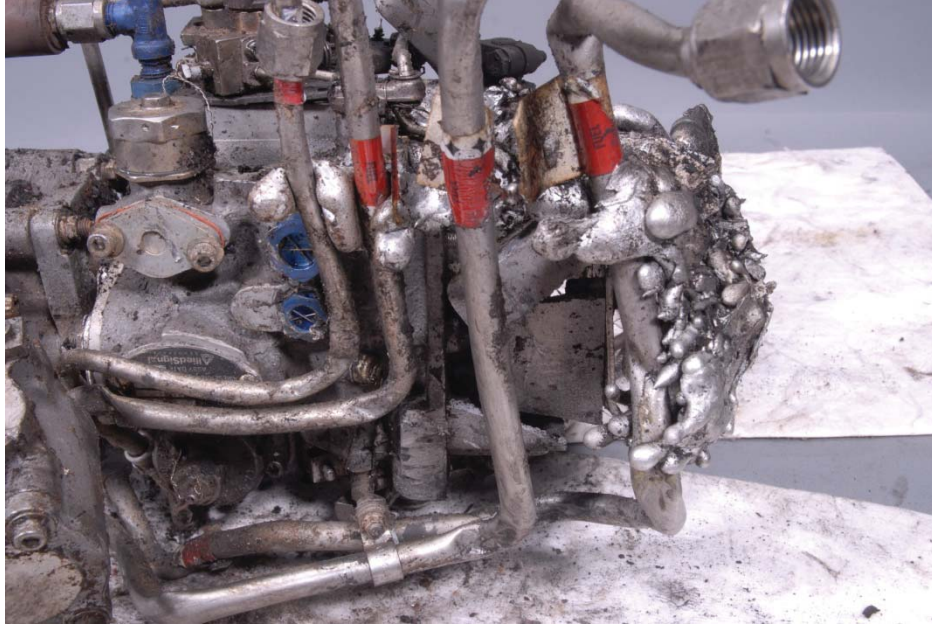
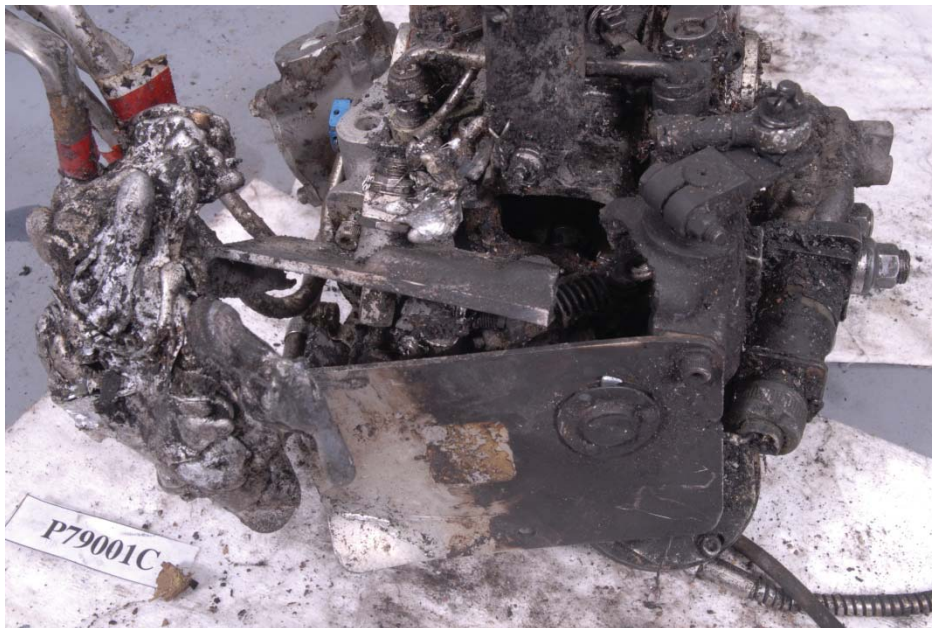
**Figure 390.** P-79001C, Fuel Control

- The fuel control assembly housing forward of the aft cover plate was fractured, exposing internal components. (Figure 392)
  - The fuel control assembly power lever shaft would rotate with resistance.

- The fuel control assembly underspeed governor input shaft would not rotate.
- (d) Fuel Filter: (Figure 393 and Figure 394)
- The fuel filter housing was fractured at the mount.

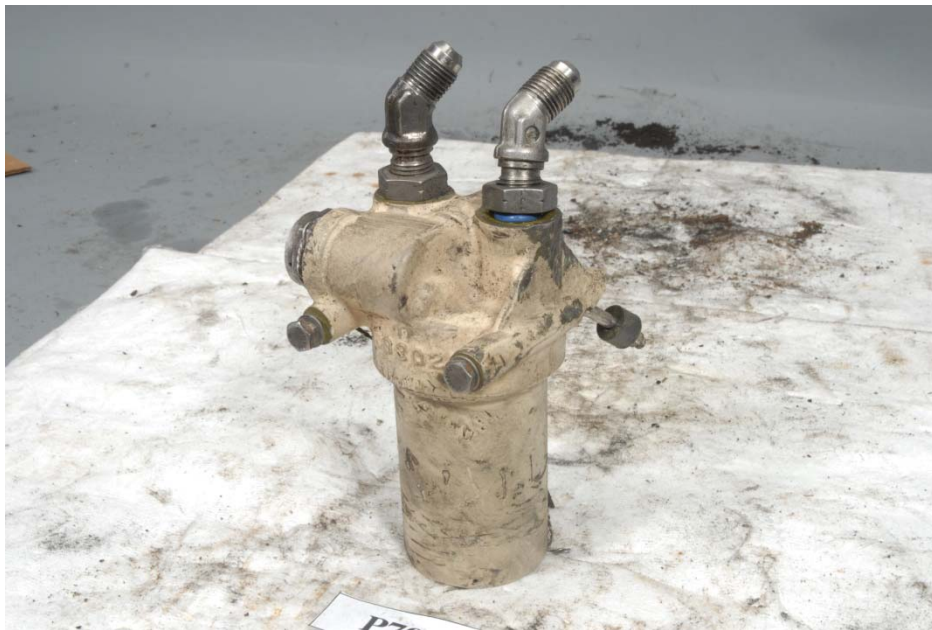
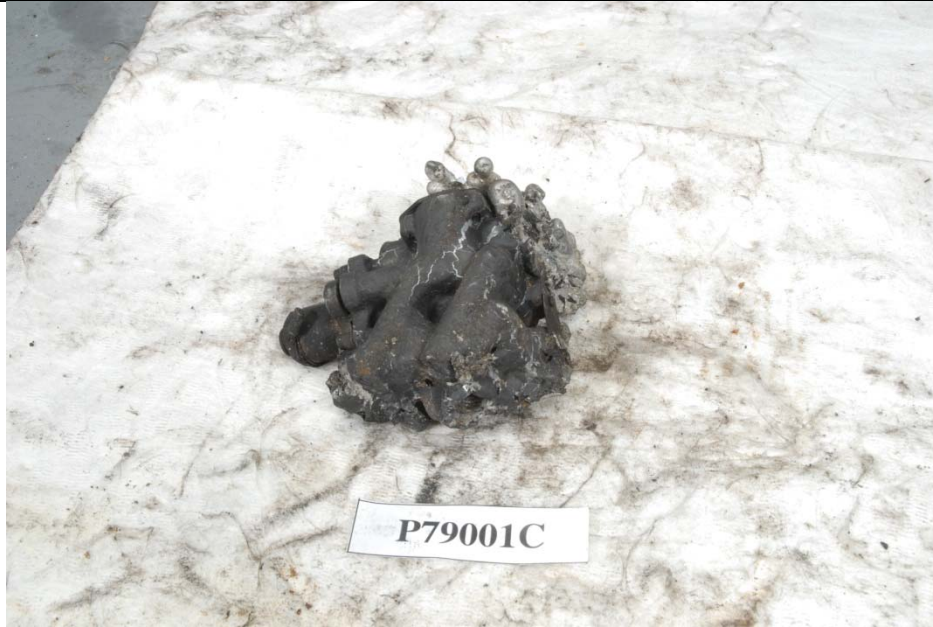
**Figure 393.** P-79001C, Fuel Filter

- The fuel filter inlet fitting was bent.
  - The fuel filter was not accessed during the examination.
- (e) Fuel Flow Divider: (Figure 395 and Figure 396)

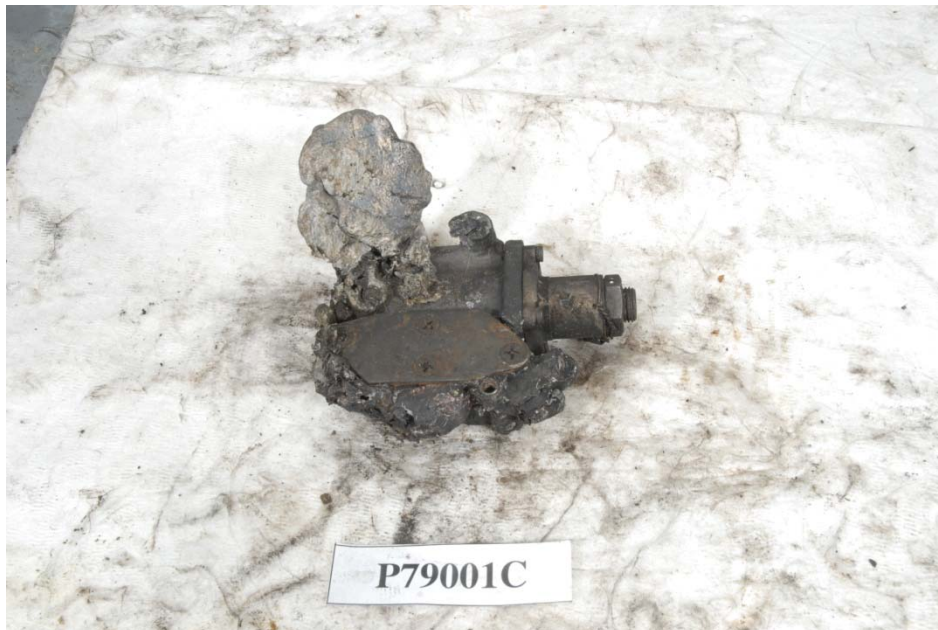
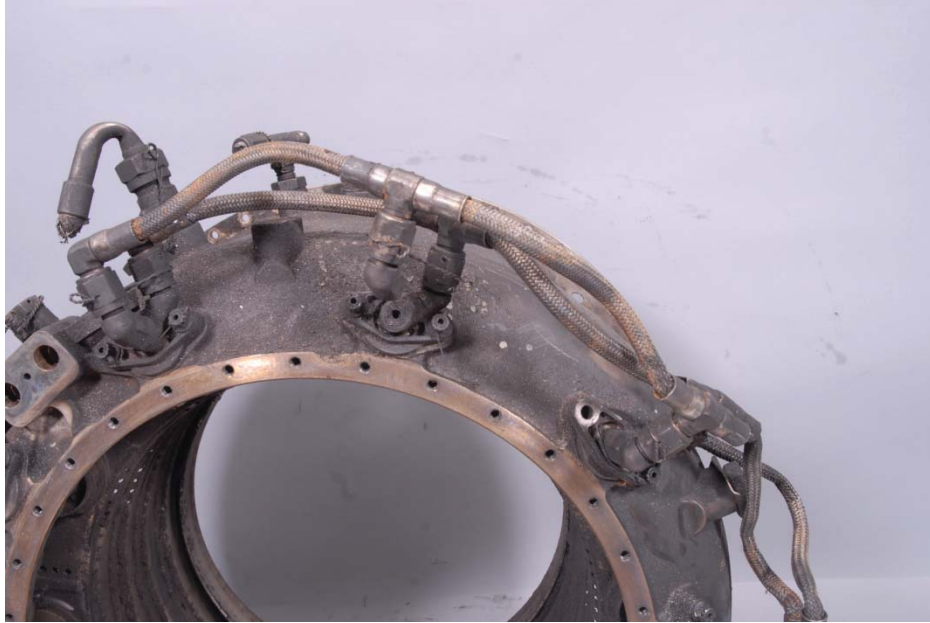
**Figure 395. P-79001C, Fuel Flow Divider**

- The fuel flow divider was partially consumed by fire.
- (f) Fuel Manifold Hose Assembly: (Figure 397 and Figure 398)
- The fuel manifold hose assembly was heavily damaged due to exposure to fire, resulting in the complete consumption of the insulation material.

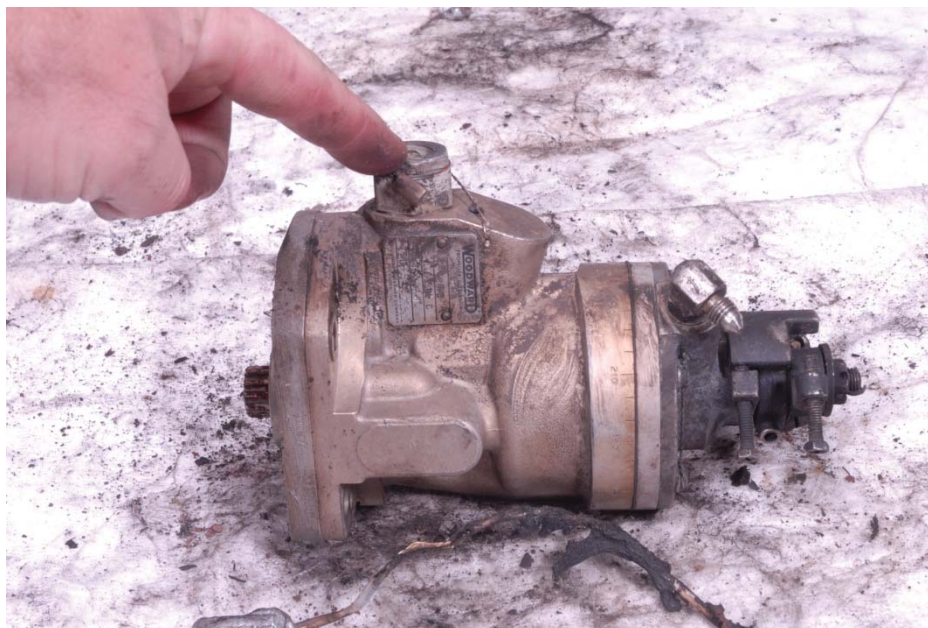
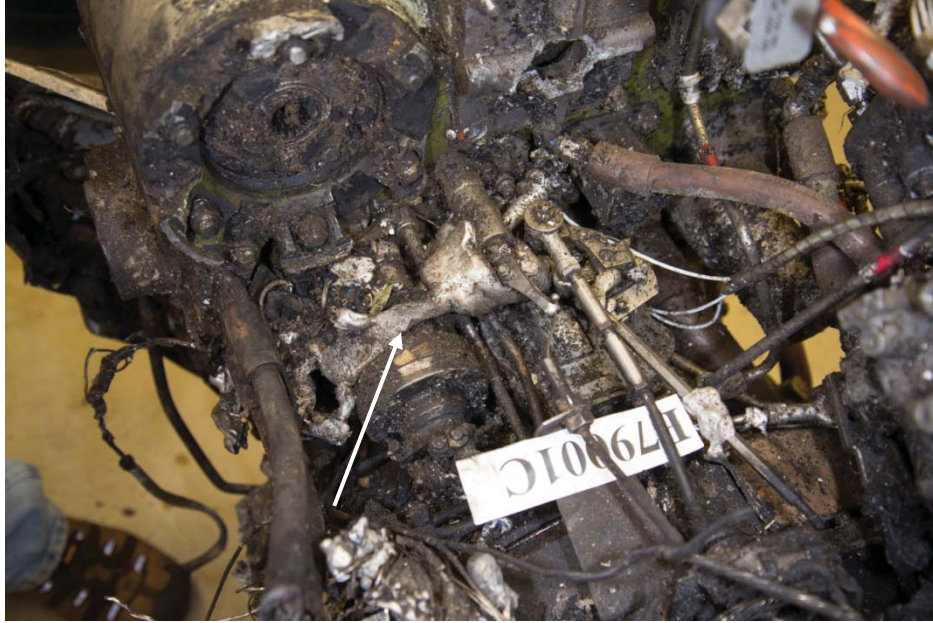
**Figure 399.** P-79001C, Propeller Governor

- (g) Propeller Governor: (Figure 399 and Figure 400)
- Part Number: 894418-6
  - Serial Number: 100865 C
  - Prior to disassembly from the gearcase, solidified molten aluminum was observed on the top the governor housing. (Figure 401)

- The propeller governor was damaged due to exposure to heat.
- (h) Propeller Pitch Control: (Figure 402, Figure 403 and Figure 404)
- Part Number: 895481-17

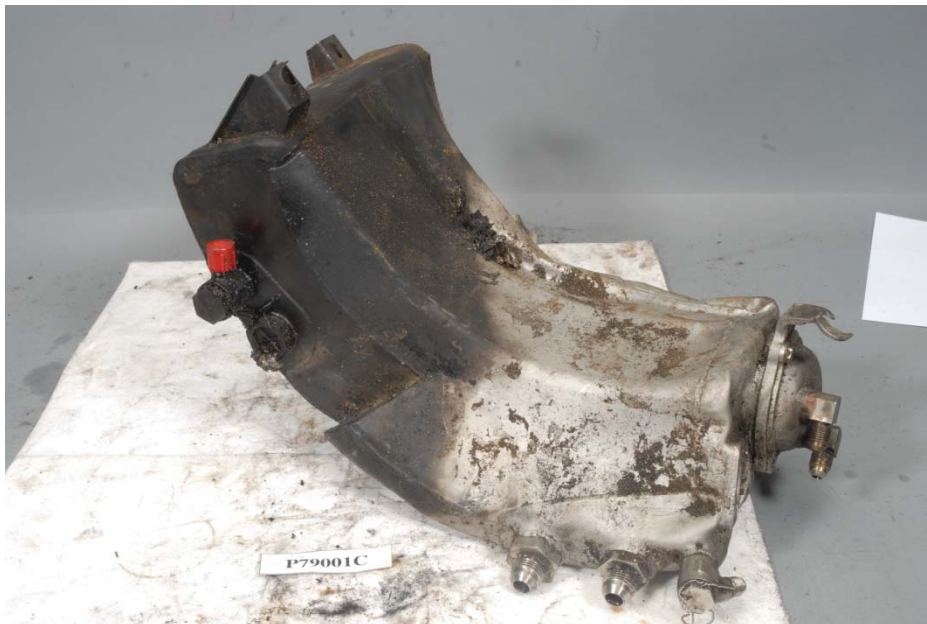
**Figure 405. P-79001C, Oil Filter**

- (i) Oil Filter: (Figure 405)
- The oil filter was not disassembled for a detailed inspection, but otherwise showed no structural damage.
- (j) Oil Tank: (Figure 406 and Figure 407)

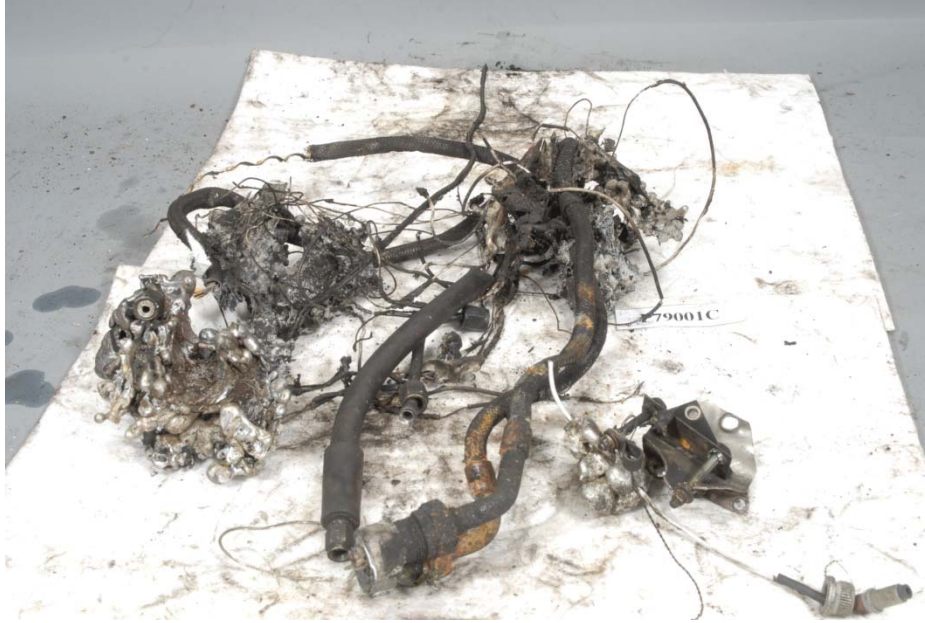
**Figure 408.** P-79001C, Ignition Exciter

- (k) Ignition Exciter: (Figure 408)
  - Part Number: Indiscernible, nameplate consumed in the fire.
  - Serial Number: Indiscernible, nameplate consumed in the fire.

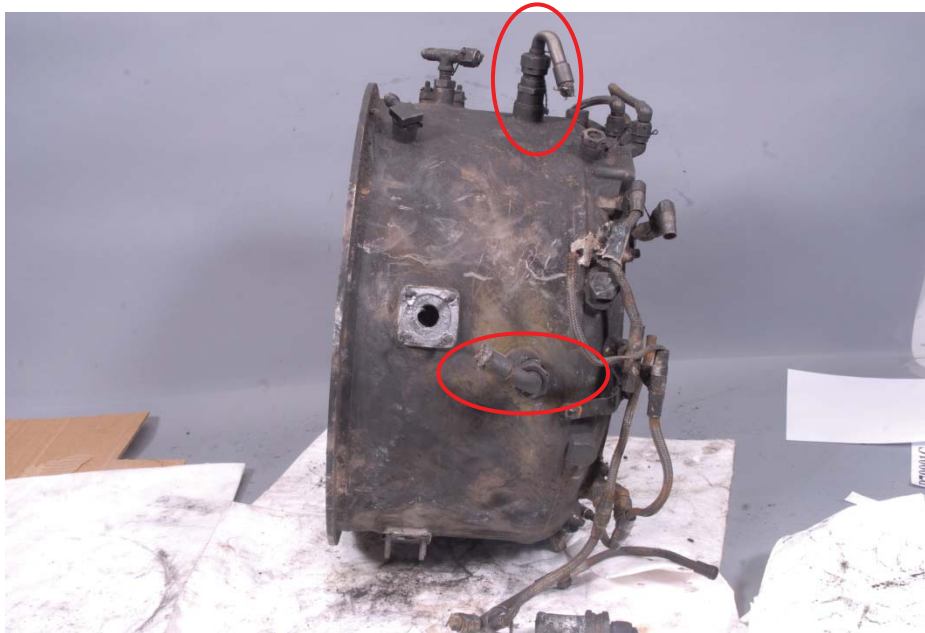
**Figure 409.** P-79001C, Exciter to Igniter Lead Assembly

- (l) Exciter to Igniter Lead Assembly: (Figure 409)
  - The exciter to igniter lead assemblies were impact damaged and separated from the igniters and the exciter.

- The exciter to igniter lead assemblies were fire damaged with solidified molten aluminum adhering to the wiring and adjacent components.
- (m) Igniters: (Figure 410)

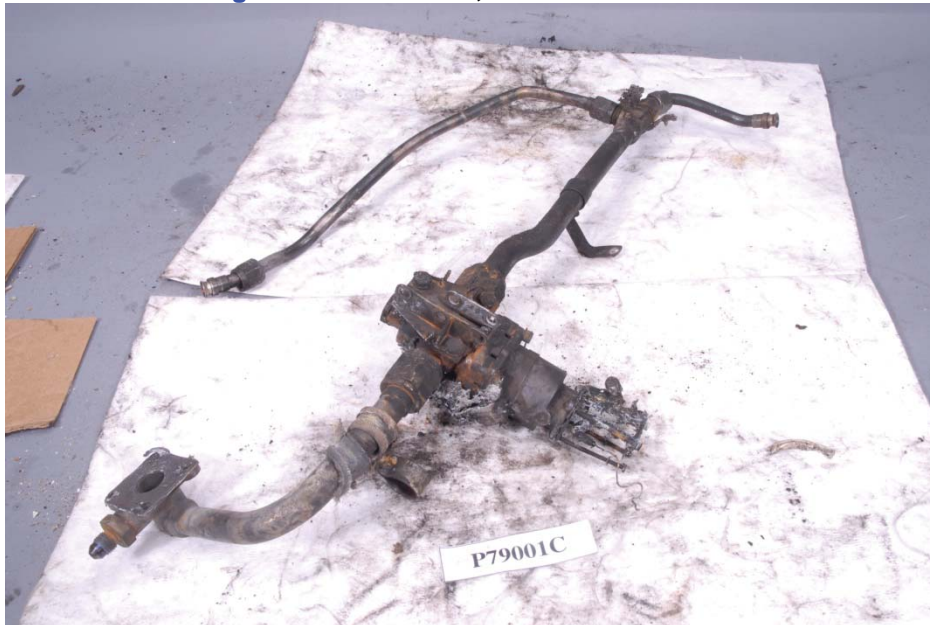
**Figure 411. P-79001C, Oil to Fuel Heater**

- (n) Oil to Fuel Heater: (Figure 411)
  - The oil to fuel heater was not accessed during the examination.
  - Residual fuel was noted coming from the oil to fuel heater.

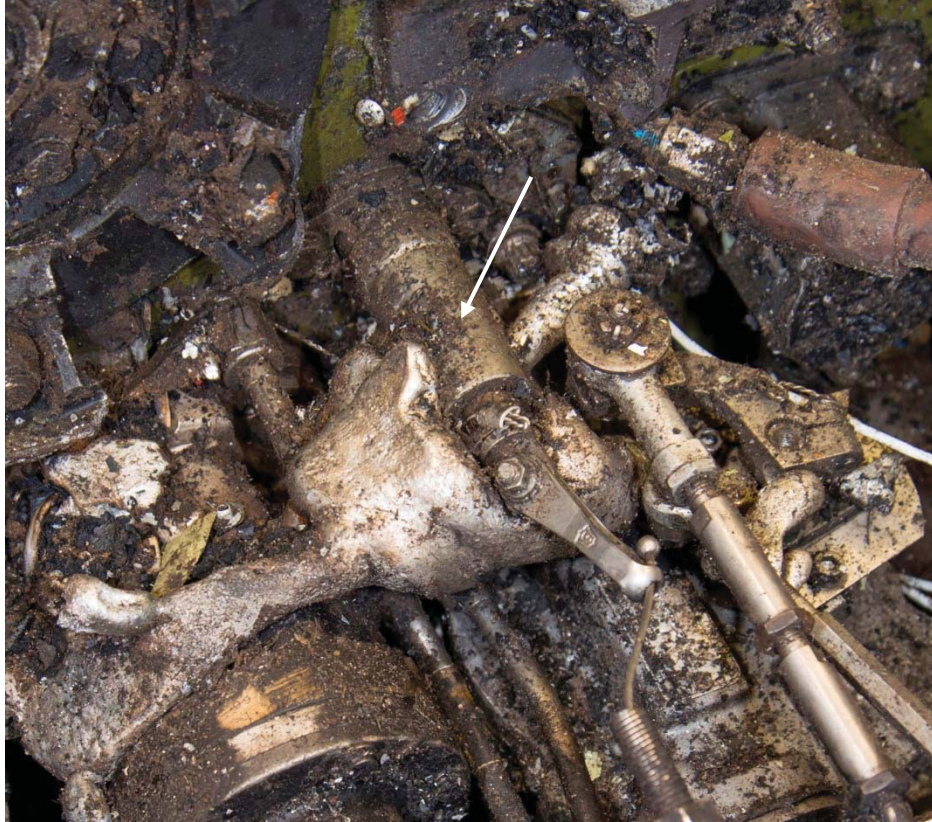
**Figure 412. P-79001C, Anti-Ice Valve**

- (o) Anti-Ice Valve: (Figure 412)
  - Part Number: 319980-1-13
  - Serial Number: P9991
  - The anti-ice valve solenoid was partially consumed by fire.
  - The anti-ice valve exterior surfaces were covered with black, ash-like debris, including solidified molten aluminum.

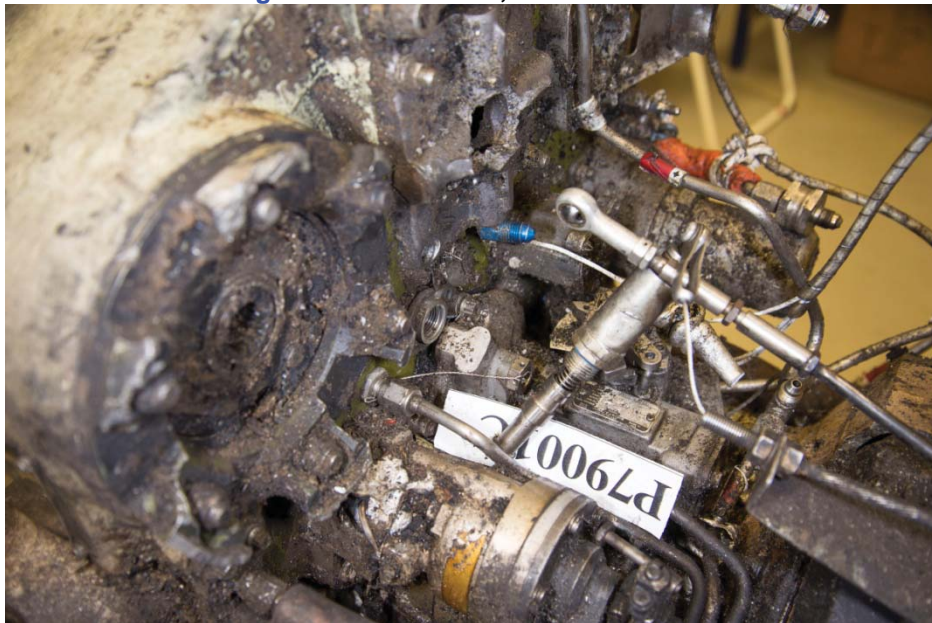
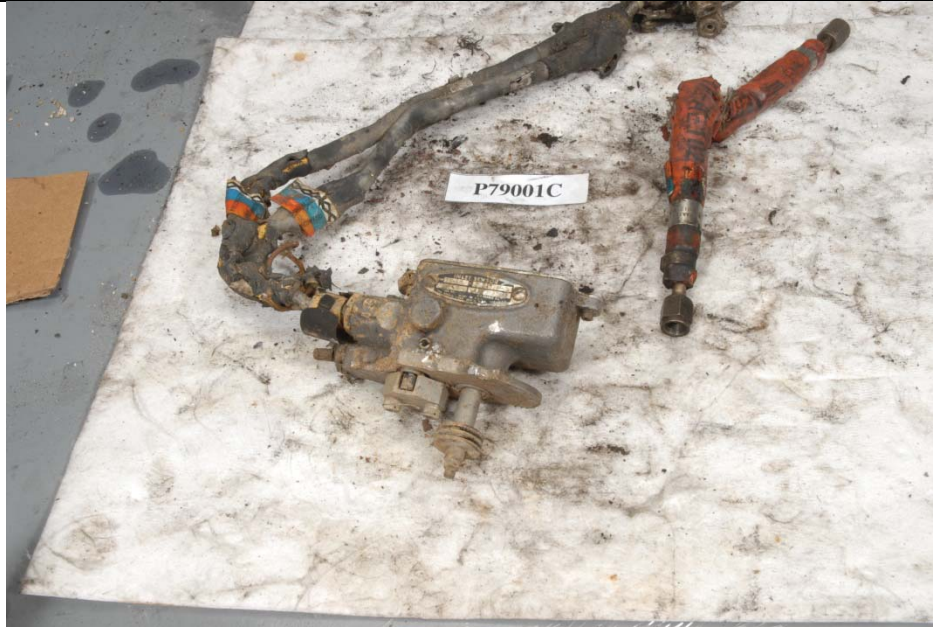
**Figure 413. P-79001C, Feather Valve**

- (p) Feather Valve: (Figure 413 and Figure 414)
  - The feather valve appeared to be intact.
  - The feather valve exterior surfaces were covered with black, ash-like debris and solidified molten aluminum prior to disassembly from the gearcase.

- The feather valve was damaged due to exposure to heat.
- (q) P2T2 Inlet Sensor: (Figure 415)
  - The P2T2 inlet sensor displayed signs of impact damage on the temperature sensor coils, and was fractured from the gearcase.

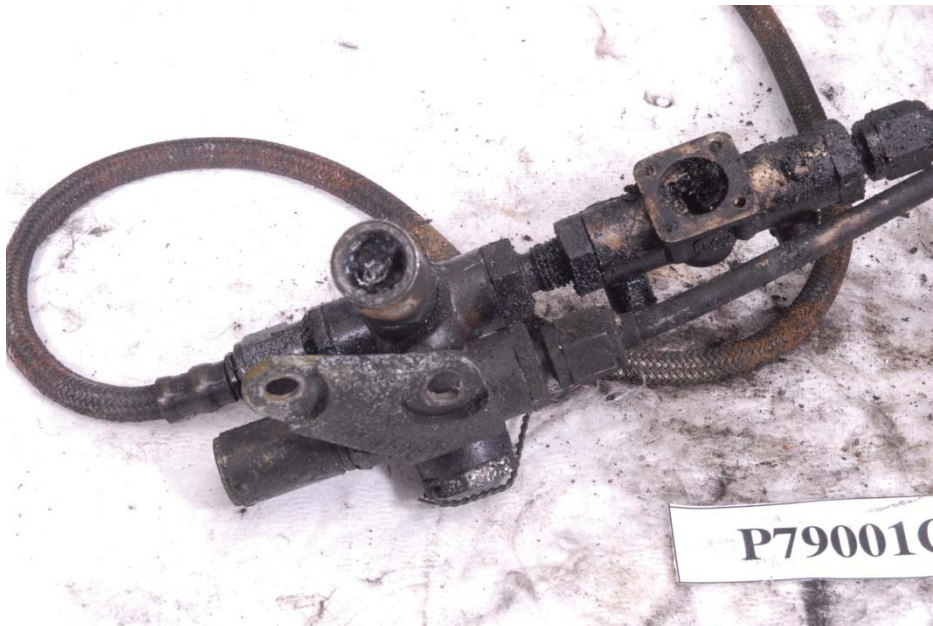
**Figure 415.** P-79001C, P2T2 Inlet Sensor

- There was earthen debris adhering to the P2T2 inlet sensor coil and external surfaces.
- (r) Beta and Negative Torque Sensing (NTS) Switch Manifold: (Figure 416)
